AIRCRAFT ACCIDENT REPORT

DELTA AIR LINES, INC.

DOUGLAS DC-9-31, N975NE

REPORT NUMBER: NTSB-AAR-74-3

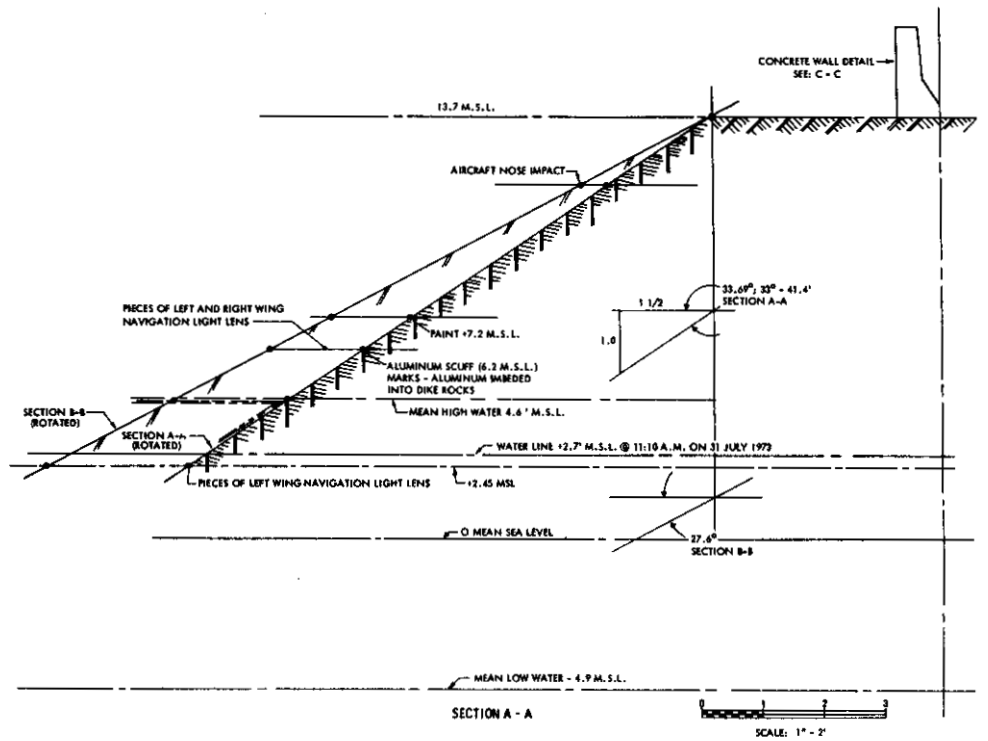
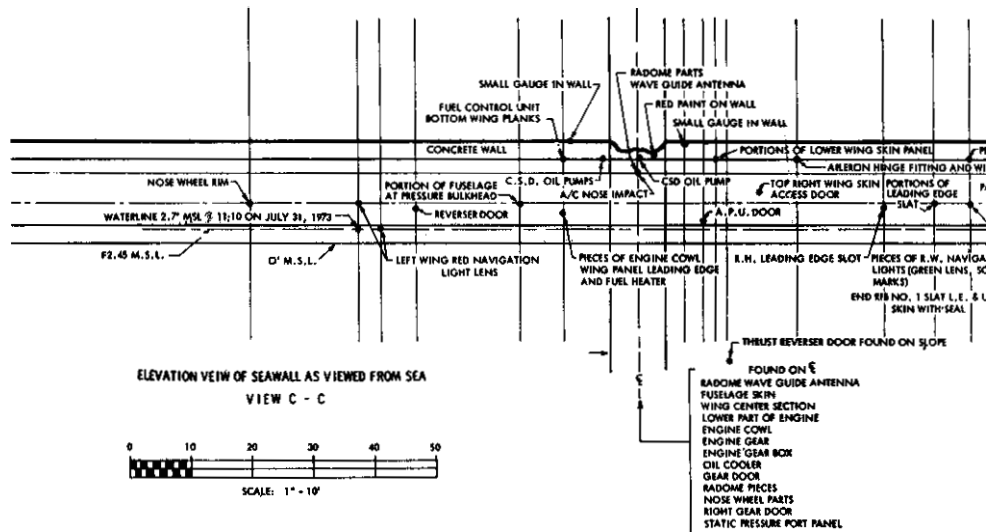
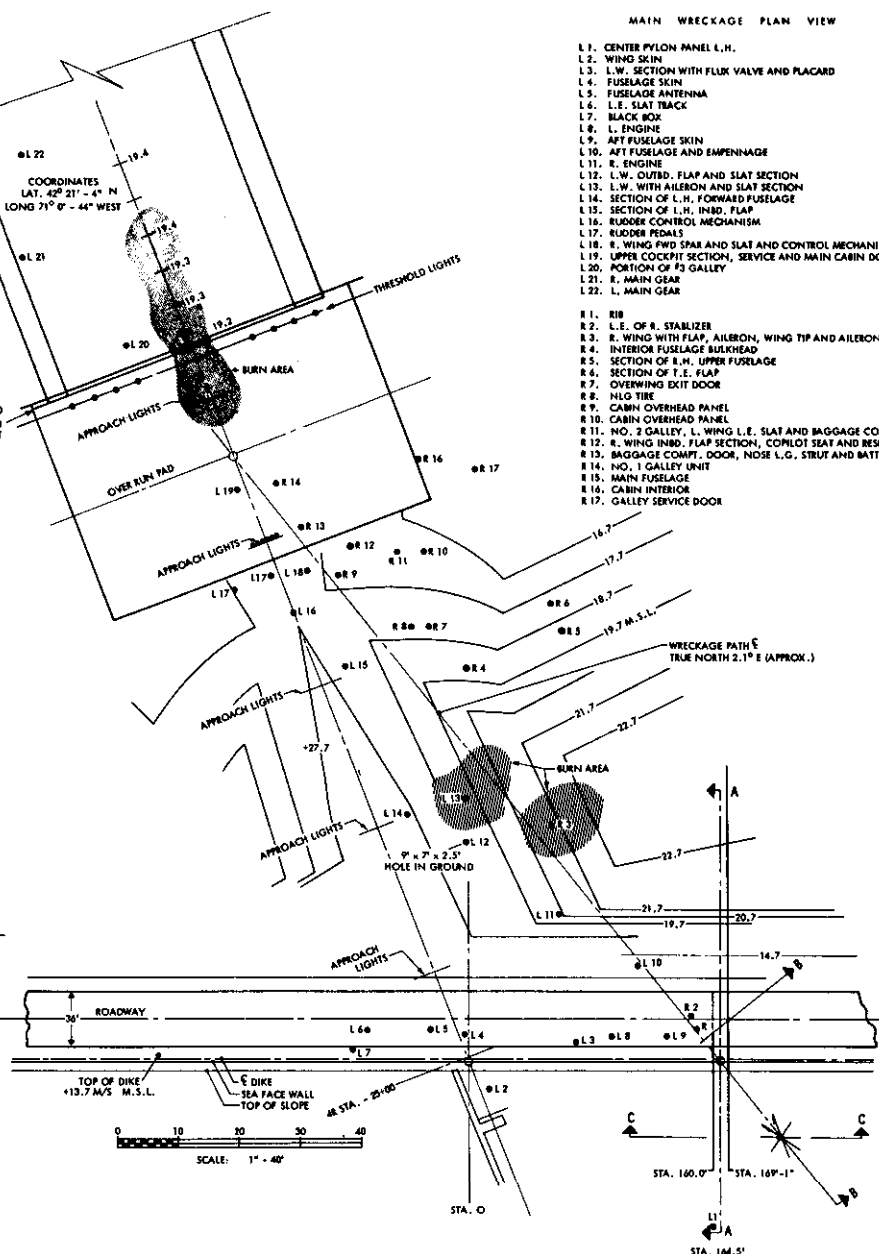
MAIN WRECKAGE PLAN VIEW

The aircraft struck a seawall on the north shore of the Boston Harbor main ship channel. The seawall forma the south boundary of the airport. The elevation of the impact point was 11.45 feet; the elevation of the intended touchdown point was 16 feet. Aluminum scuff marks were found on the rocks 6.2 feet up the seawall. Pieces of wing tip navigation lights were found at each end of the scuff marks. Portions of wing and fuselage structure were found between the edge of the water and the base of the wall. The aircraft wreckage was scattered along a magnetic heading of 017° in an area about 250 feet wide and 790 feet long. (See Appendix H.)
